| Critical sections of the Danube River | | | |
| Klížská Nemá 1 | | | |

rkm:  
1792.1 - 1791.6

page:  
12/24

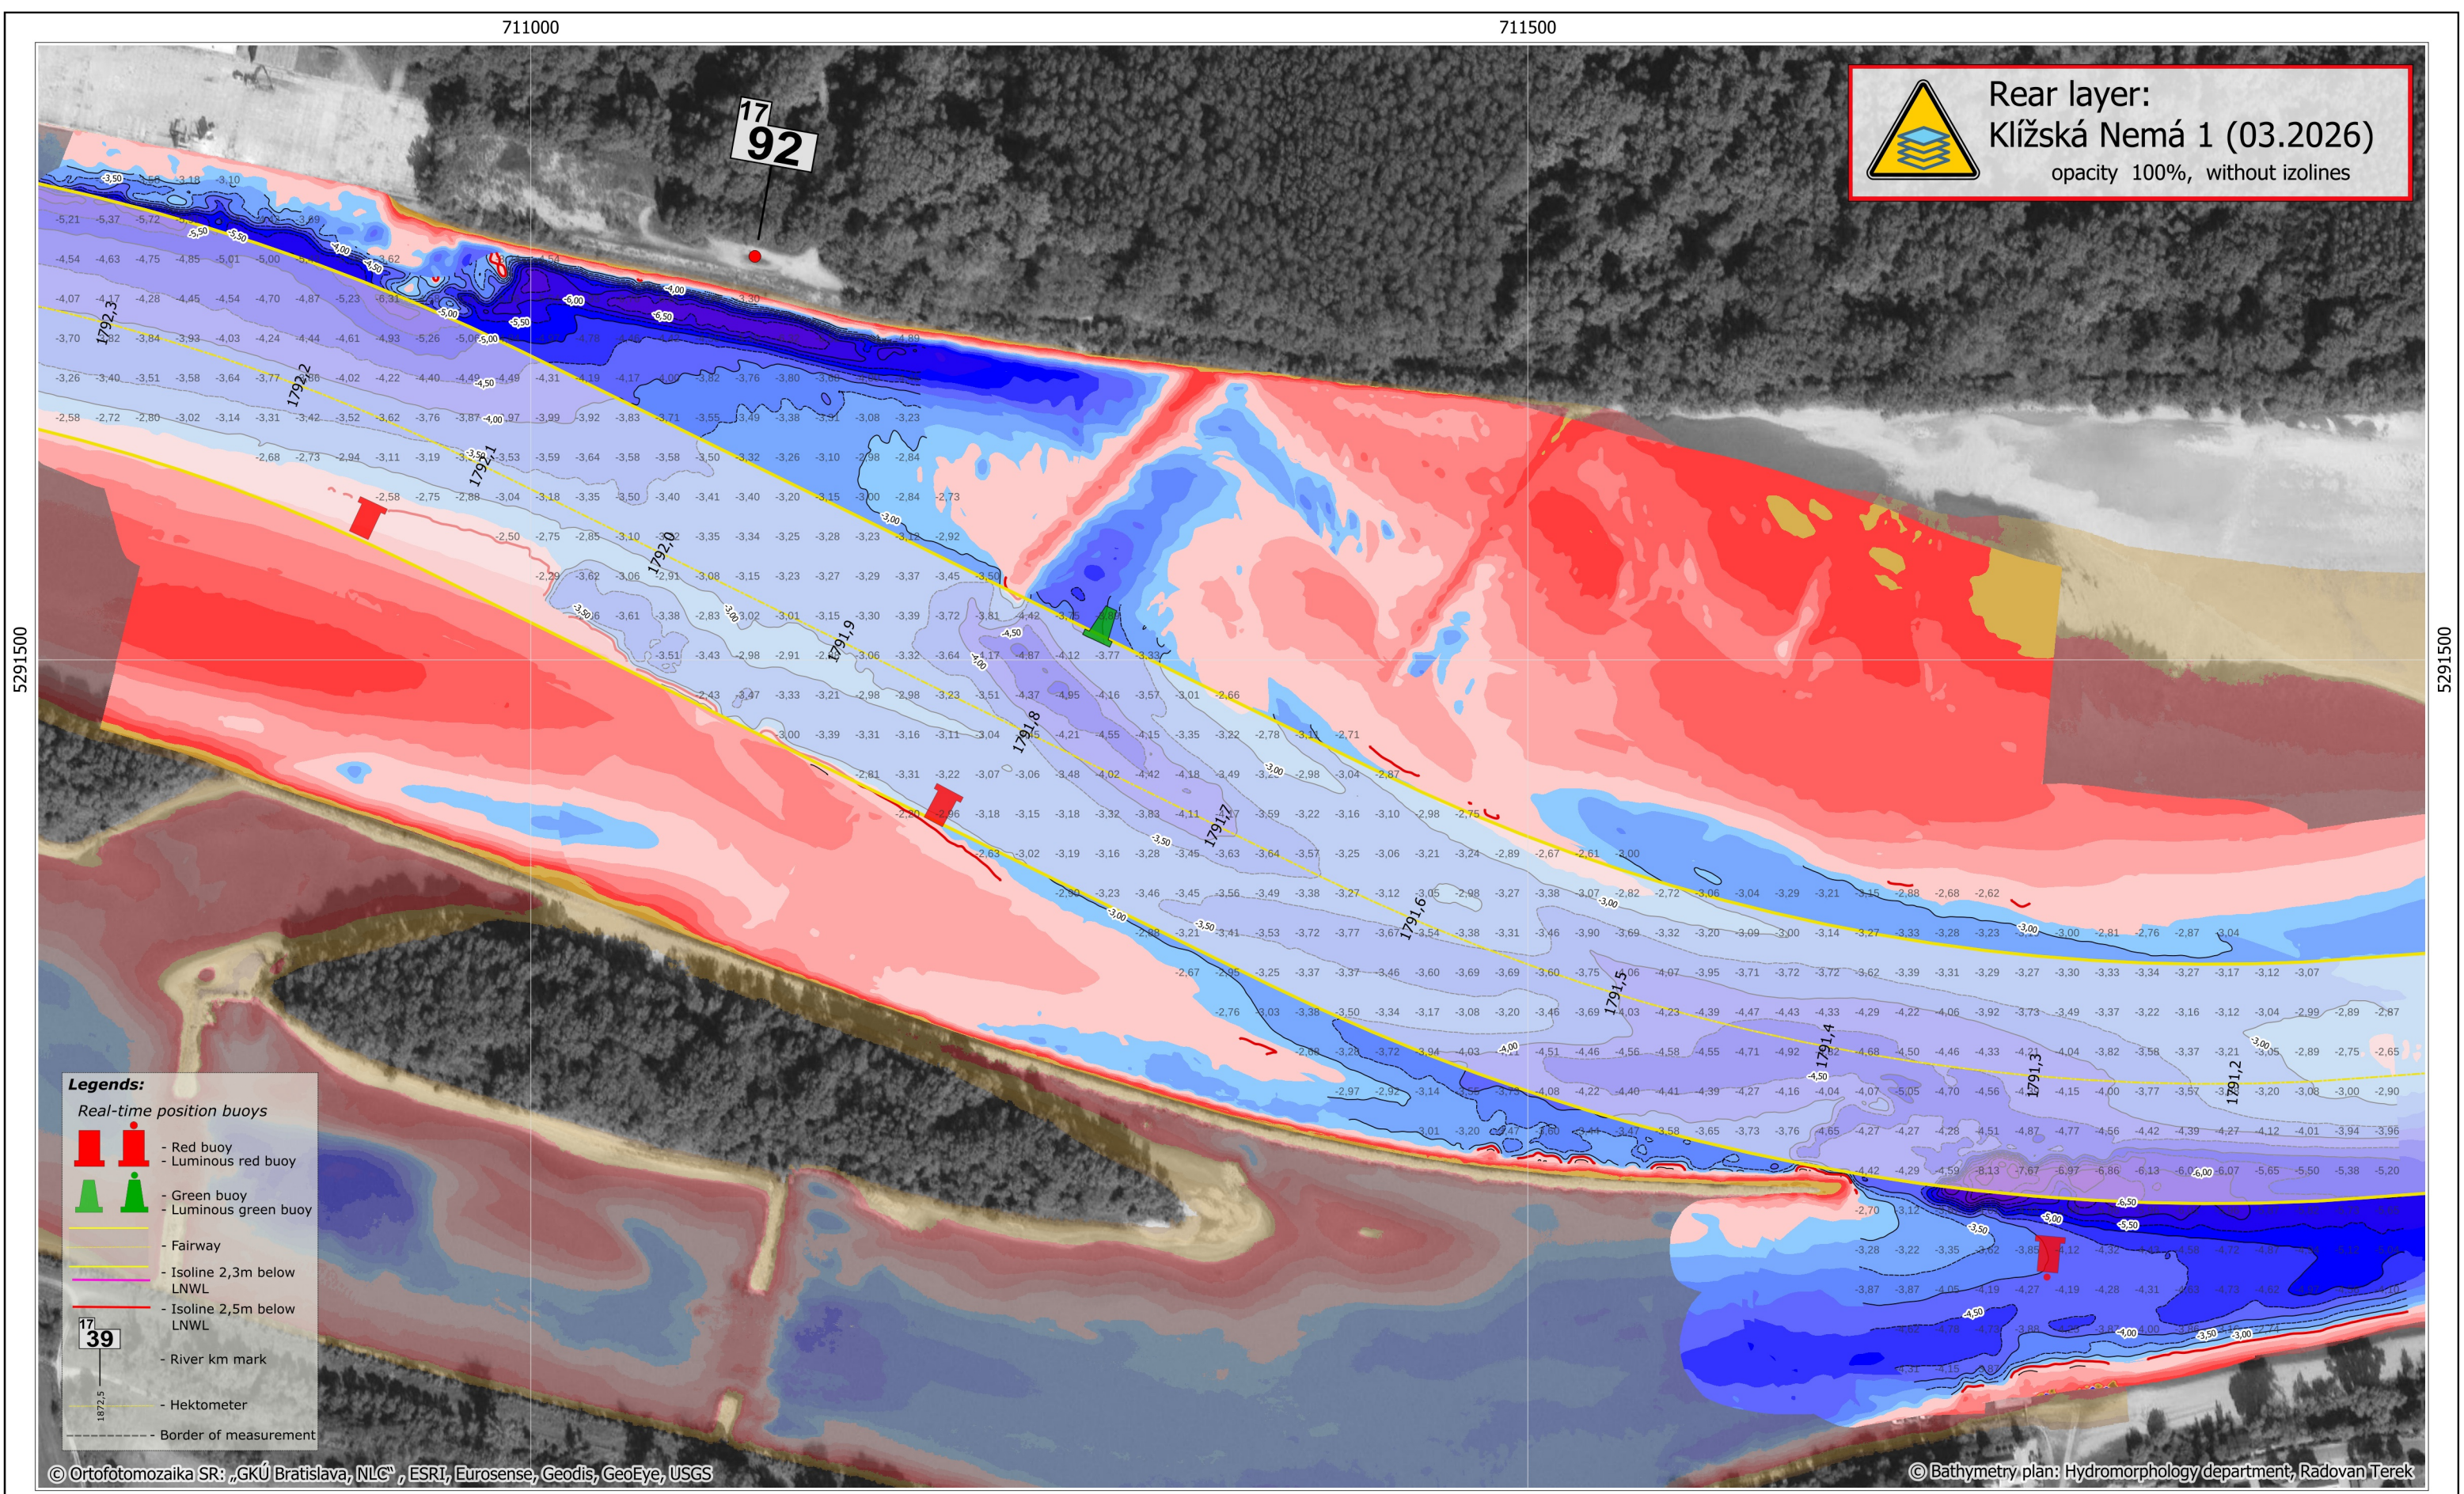
Rear layer:  
Klížská Nemá 1 (03.2026)  
opacity 100%, without isolines

| Critical sections of the Danube River | | | |
|---|---|---|---|
| date of measurement : | 07.09.2026 | gauge value : | Gönyű -69 cm |
